NEW MEXICO STATE UNIVERSITY

Transportation Asset Master Plan

NOVEMBER 2020

**NEW MEXICO STATE UNIVERSITY
TRANSPORTATION ASSET
MANAGEMENT PLAN**

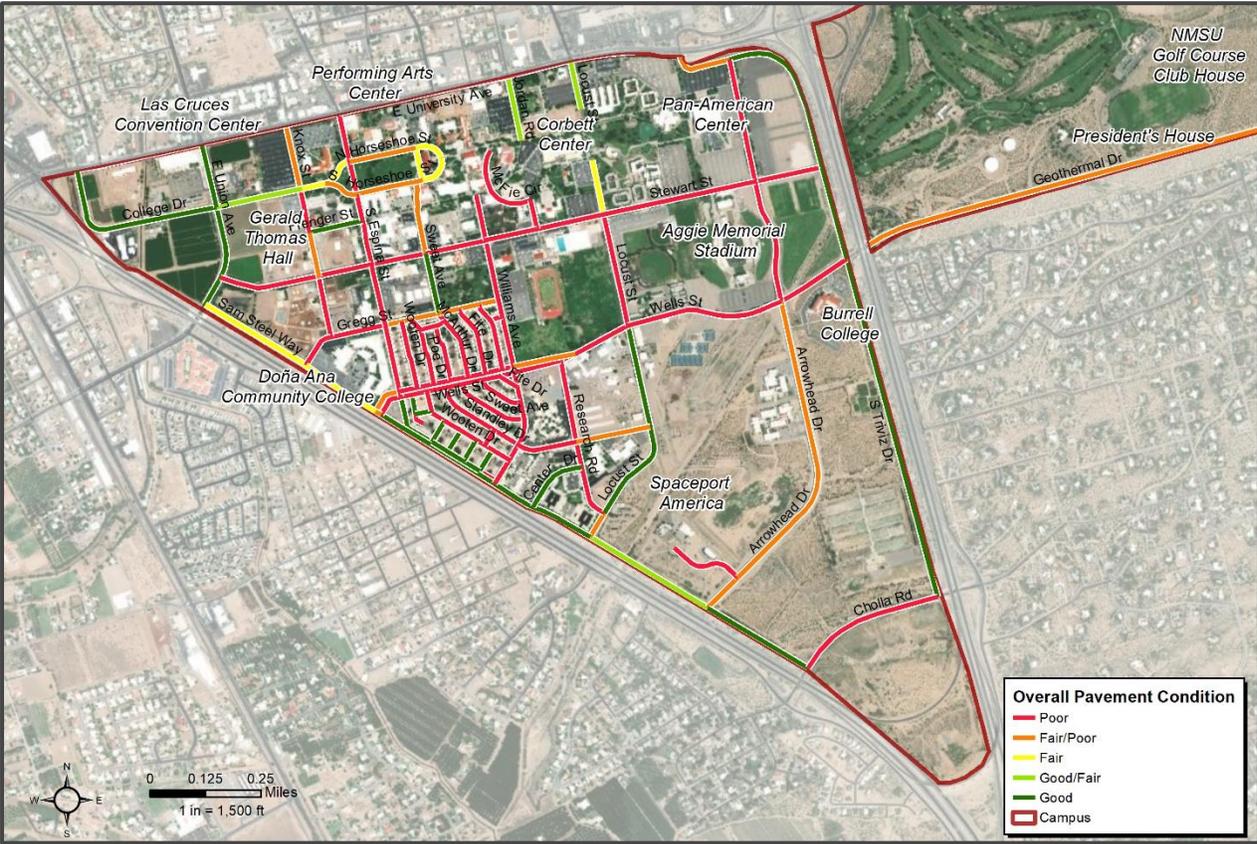
Figure 5: Overall Pavement Condition

Pavement Condition	Total Length (mi.)	Percent of Total
Good	1.86	14.0%
Good/Fair	0.46	3.5%
Fair	0.47	3.5%
Fair/Poor	2.31	17.3%
Poor	8.23	61.8%
TOTAL	13.33	100%

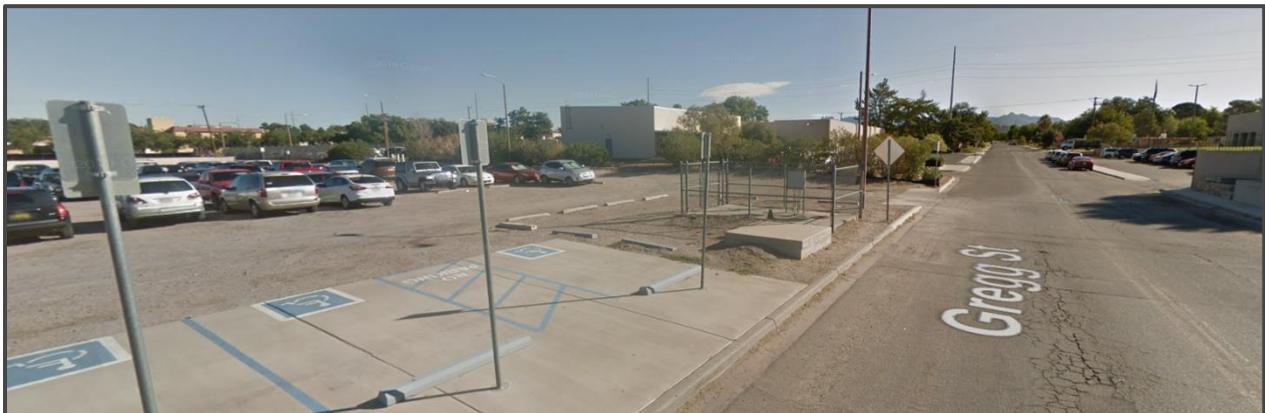
Figure 6: Gregg St. Sidewalk Obstruction - Sidewalk Gap and Signpost

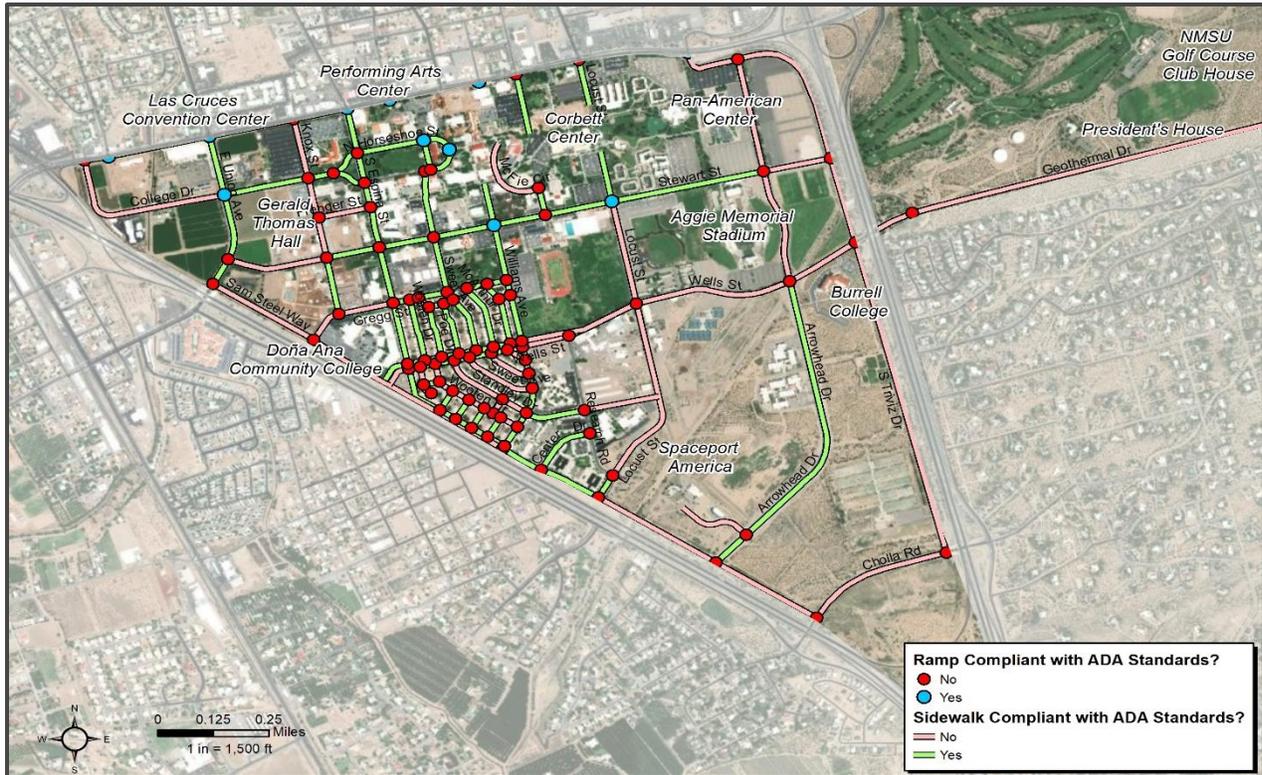
Figure 7: Overall ADA Compliance - Curb Ramps and Sidewalks

Criteria	Total	Percentage of Total
Total Intersections Evaluated	97	100.0%
Intersections with Curb Ramps Missing	51	52.6%
Intersections with Width Improvements Needed	61	62.9%
Intersections with Slope Improvements Needed	61	62.9%
Intersections with Missing Warning Surfaces	81	83.5%
Intersections with Missing Sidewalk Connections	12	12.4%
Intersections with Missing Push Buttons	1	1.0%
Intersections with Curb Ramp Obstructions	1	1.0%
Intersections with Crosswalk Obstructions	5	5.2%
Total Intersections Compliant with ADA Standards*	10	10.3%

**ADA compliance was determined by identifying the campus intersections which lack ramps or warning surfaces, contain obstructions, or have nonconforming slope or width. As some intersections may contain multiple issues which make them noncompliant, the total amount of noncompliant sidewalks will not add up to the total amount of issues observed.*
