# NM 159 VEHICLE LENGTH RESTRICTIONS

## STUDY & ANALYSIS

**NM 159 VEHICLE LENGTH RESTRICTIONS  
STUDY & ANALYSIS**

**NMDOT CN U900440**

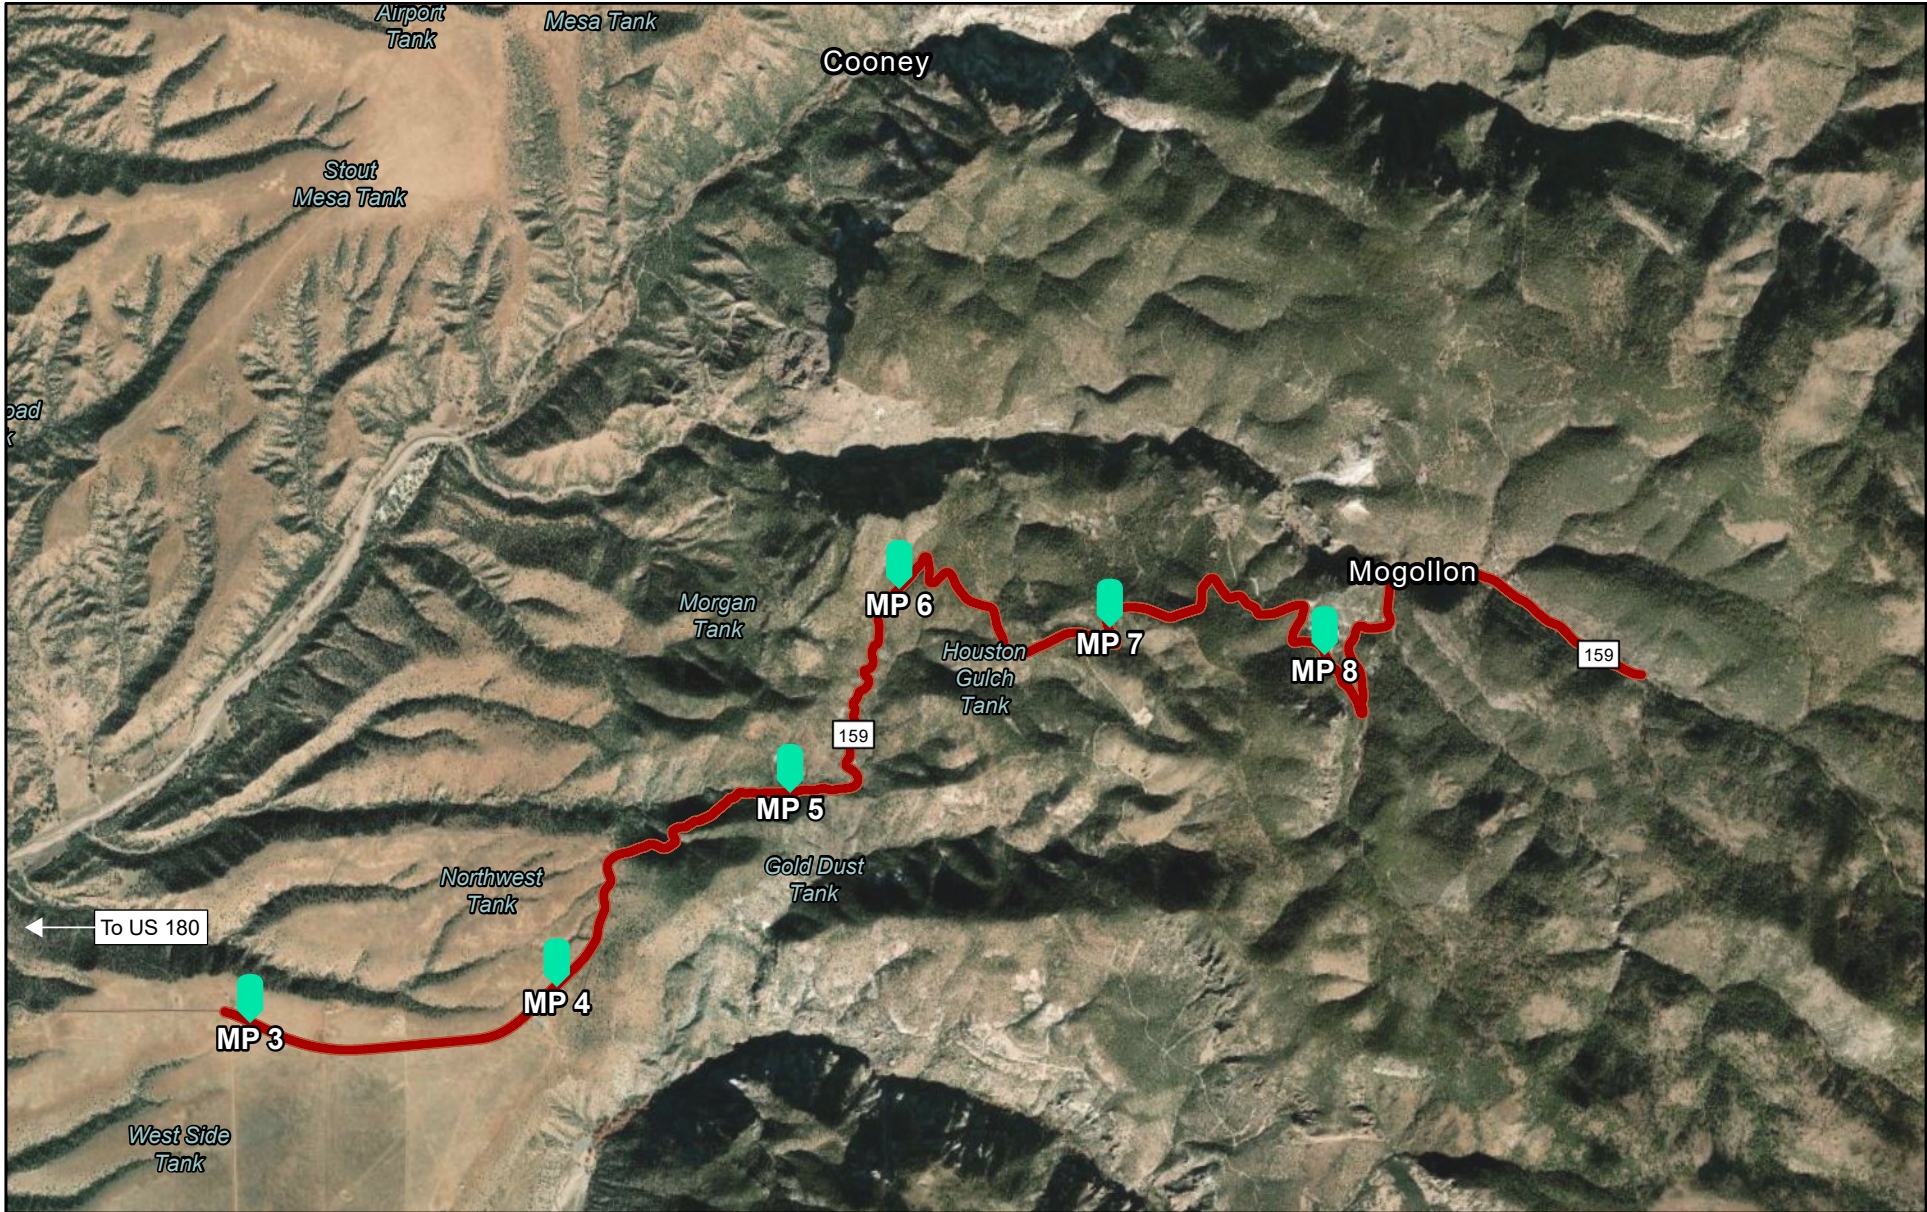
**NM 159 Vehicle Length Restrictions Study**  
*Vicinity Map*

- Mile Post
- Approximate NM 159 Centerline
